## **Dust Abatement Methods for Lines- of-Communication and Base Camps in Temperate Climates**

John F. Rushing, Vernon M. Moore, Jeb S. Tingle,  
Quint Mason, and Tim McCaffrey

October 2005

Final report

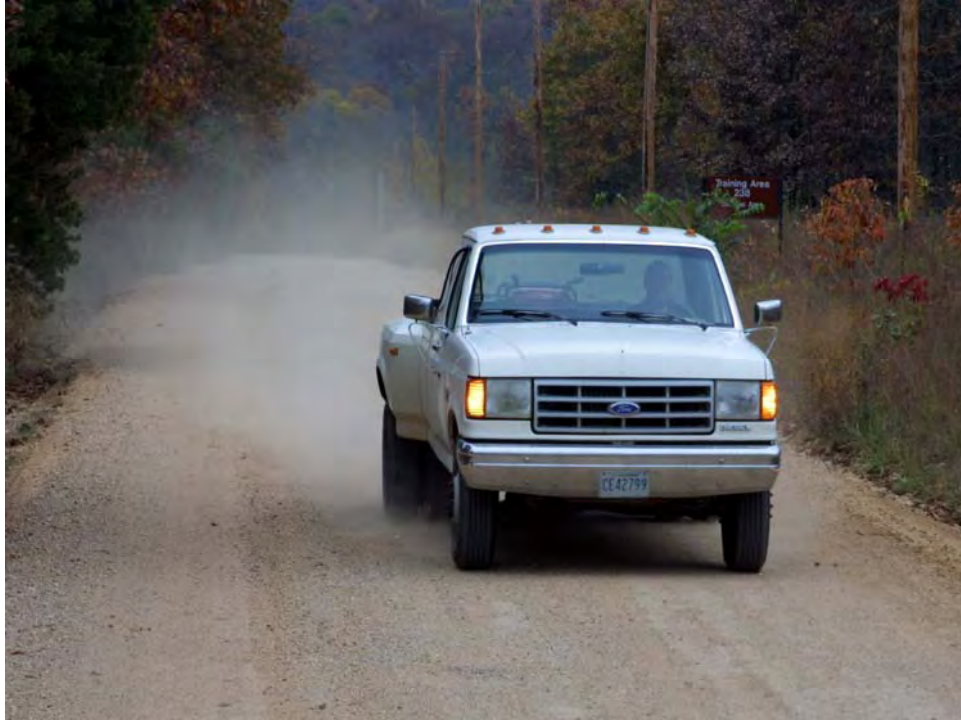
Photo 35. Dust generated on section 20 (Envirotac II® 0.8 gsy topical) during 30-day evaluation

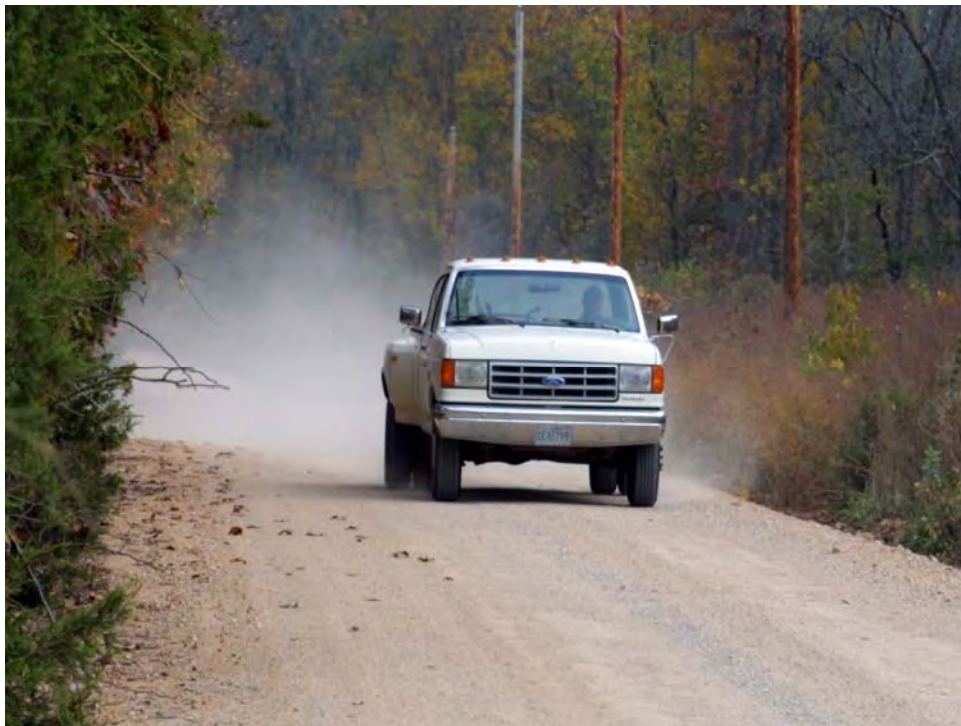
Photo 36. Dust generated on section 24 (water 0.8 gsy topical) during 30-day evaluation

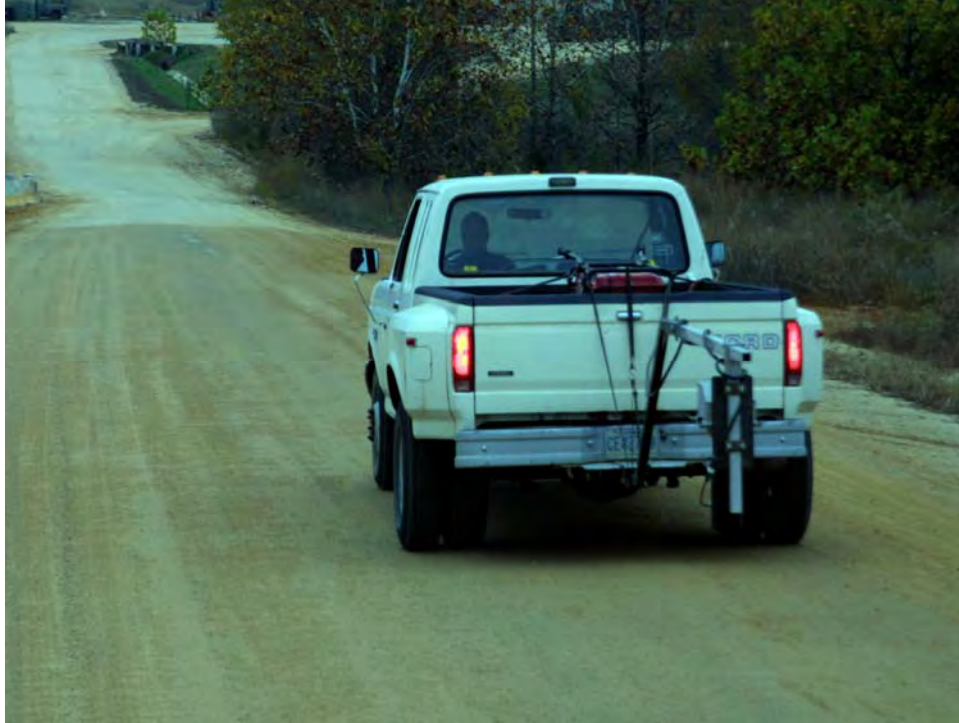
Photo 37. Dust generated on section 21 (calcium chloride 0.4 gsy topical) during 30-day evaluation

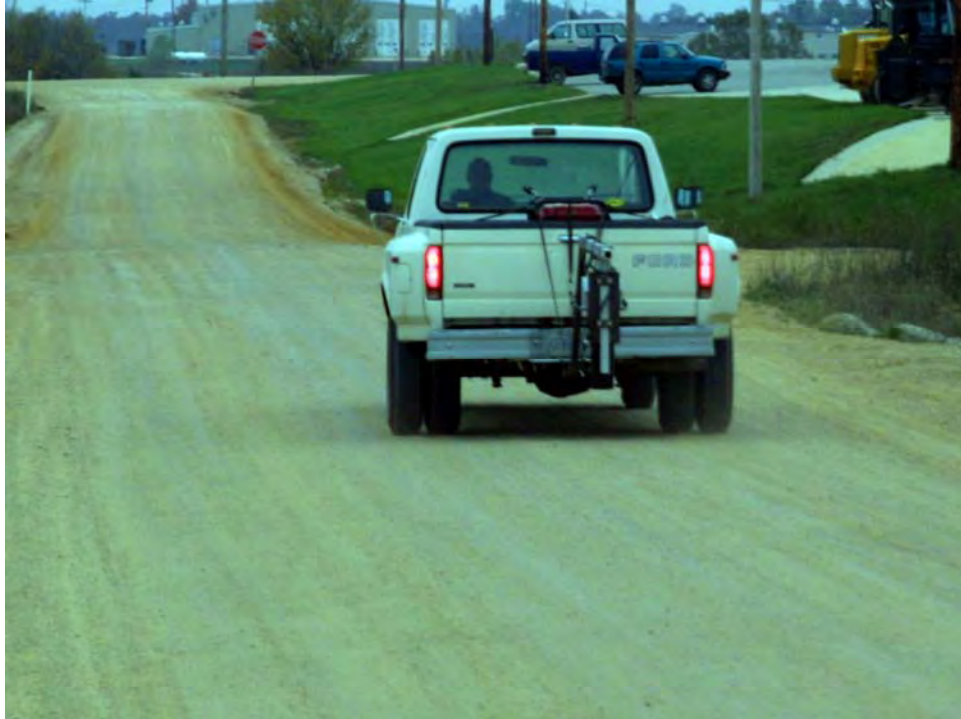
Photo 39. Dust generated on section 23 (Surtac® 0.4 gsy topical) during 30-day evaluation

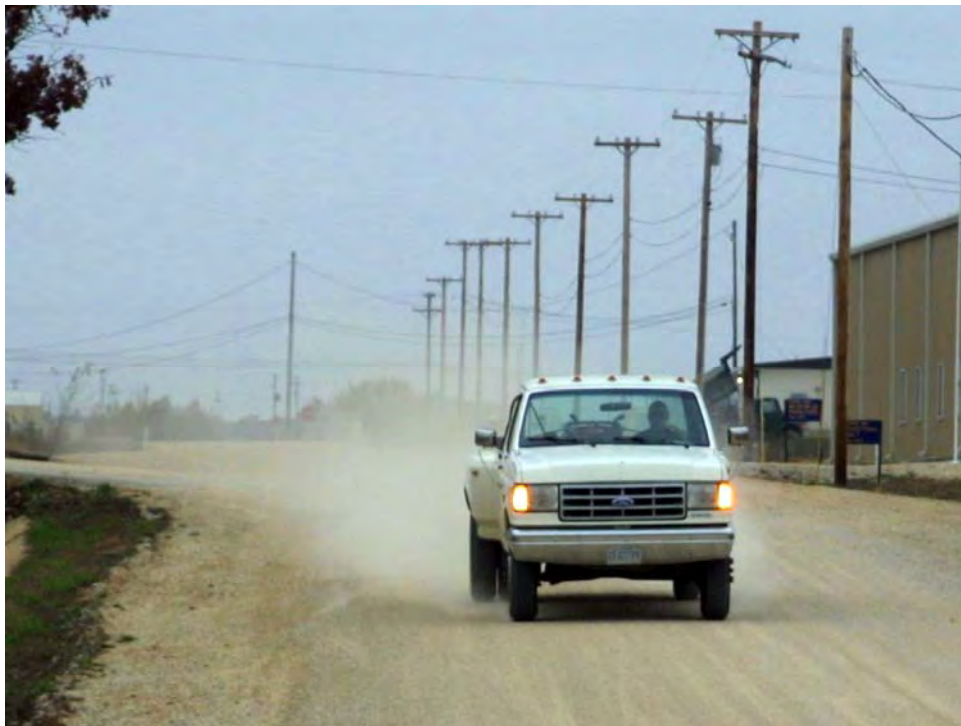
Photo 40. Dust generated on section 25 (Envirotac II® 0.4 gsy topical) during 30-day evaluation

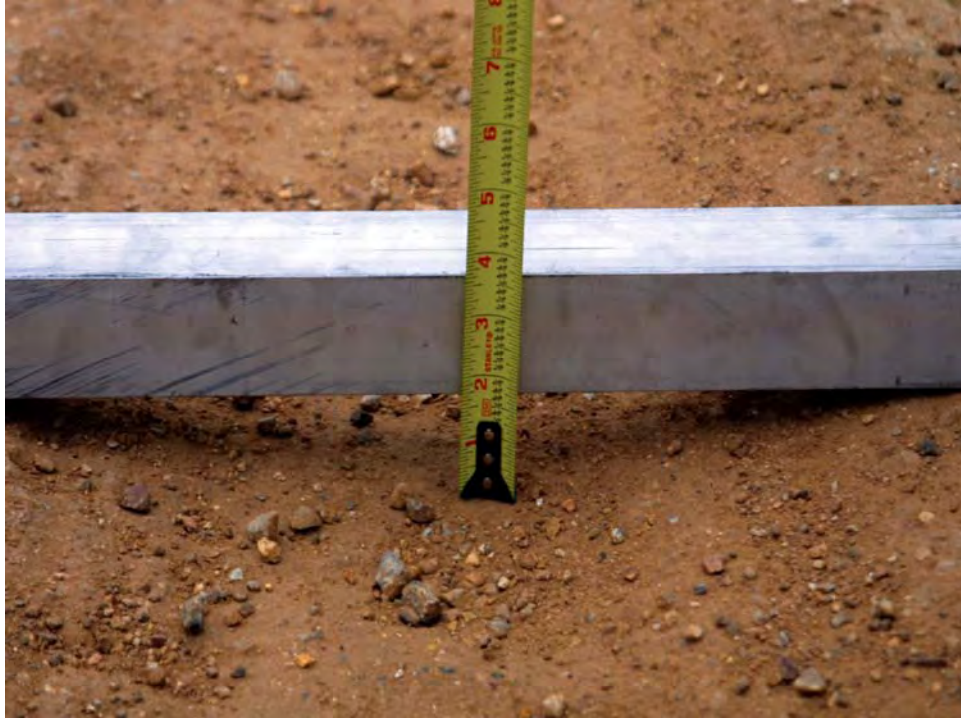
Photo 41. Rutting and dislodged aggregate in surface of section 1

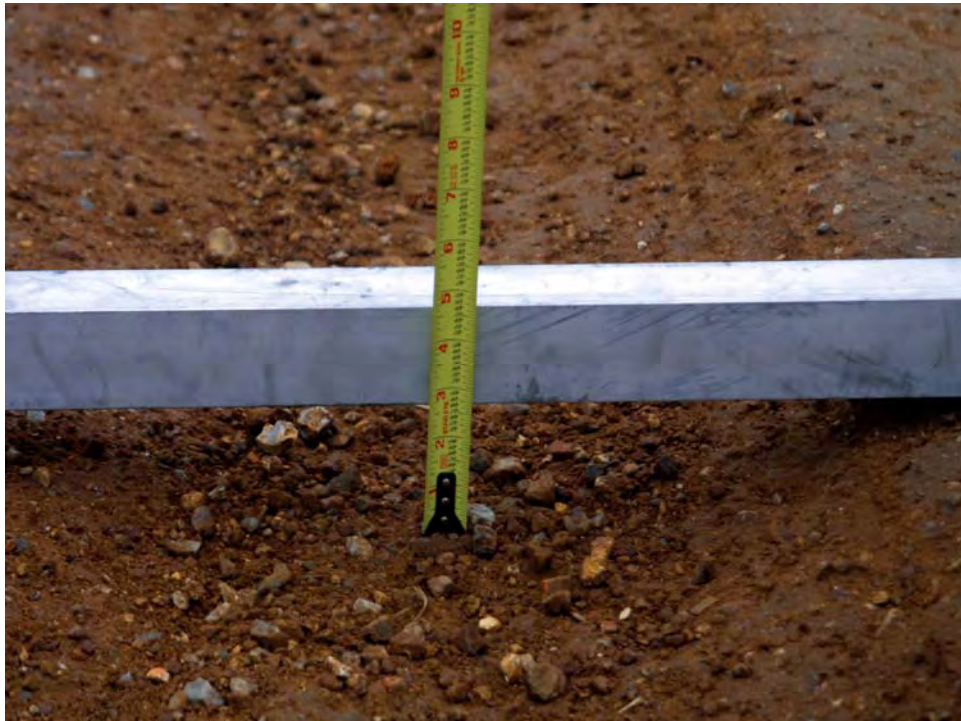
Photo 42. Densification of soil treated with calcium chloride in section 6

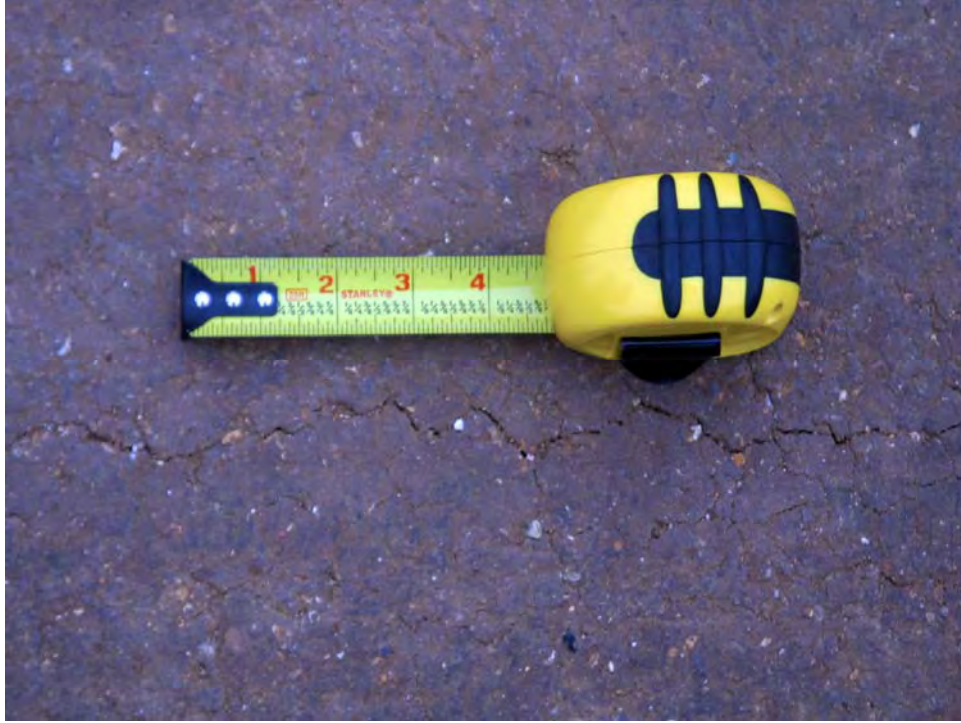
Photo 43. Longitudinal cracking in surface of section 2

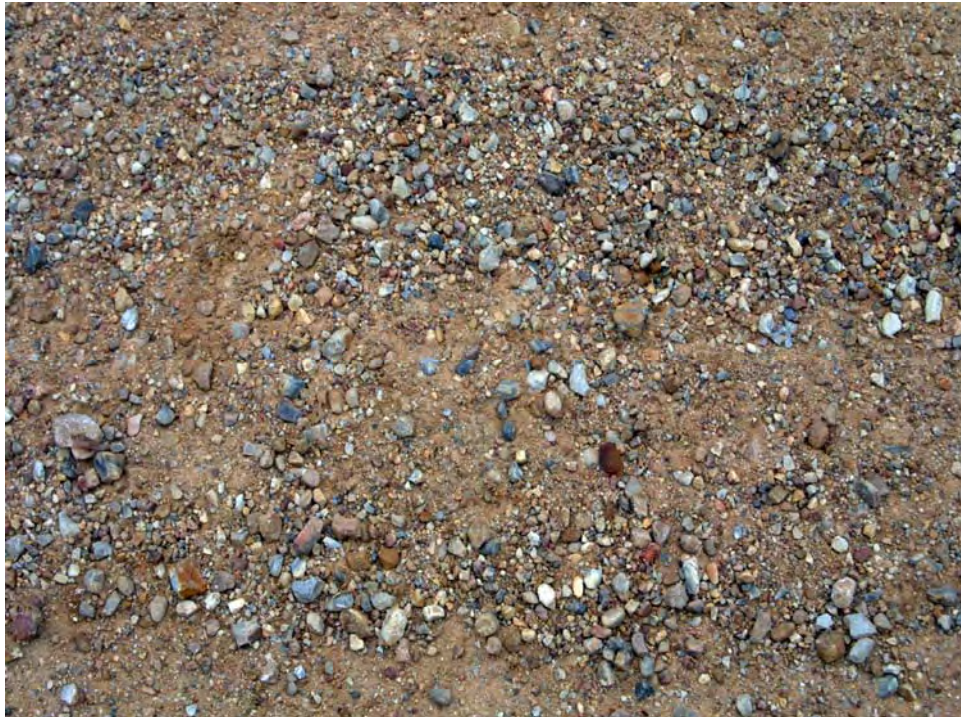
Photo 44. Aggregate raveling on surface of section 11

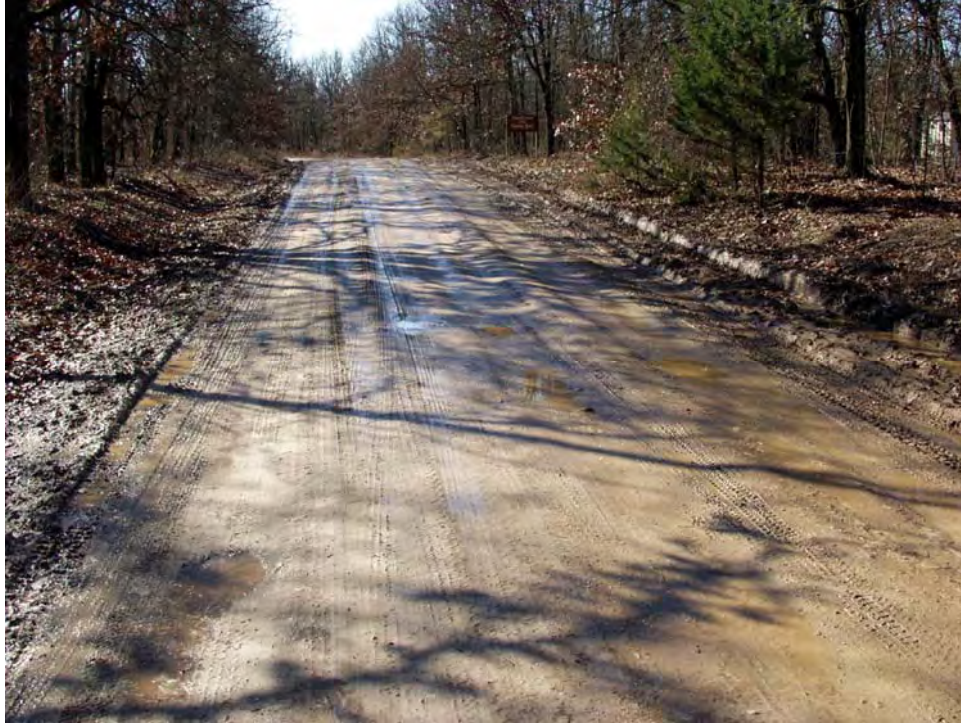
Photo 61. Section 9 (water 0.8 gsy admix) - medium improper cross section

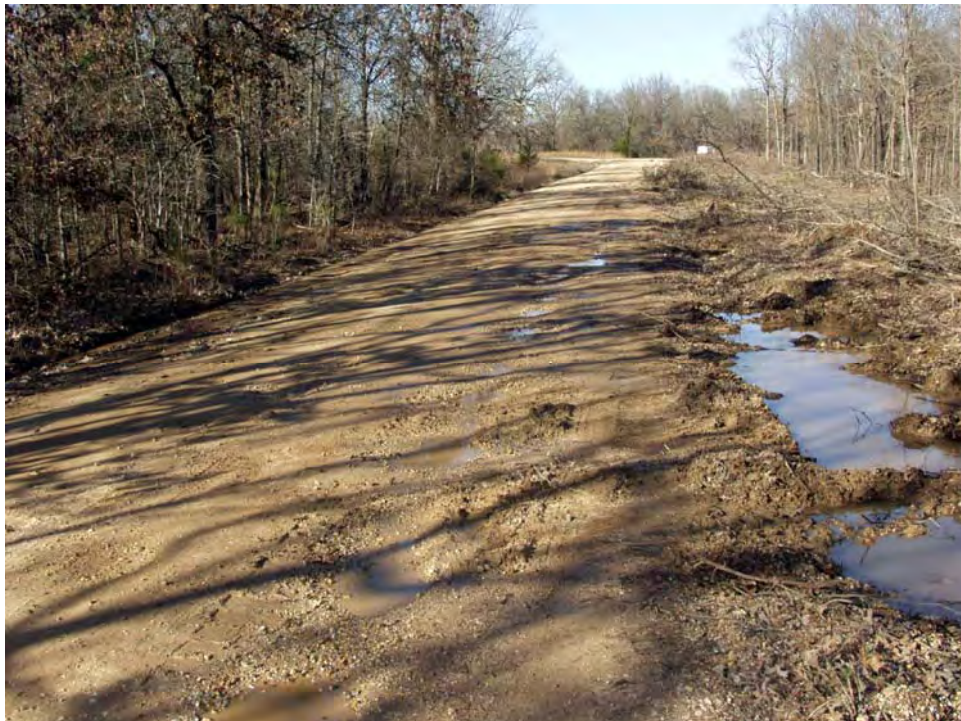
Photo 62. Section 12 (Surtac® 0.4 gsy admix) - inadequate roadside drainage

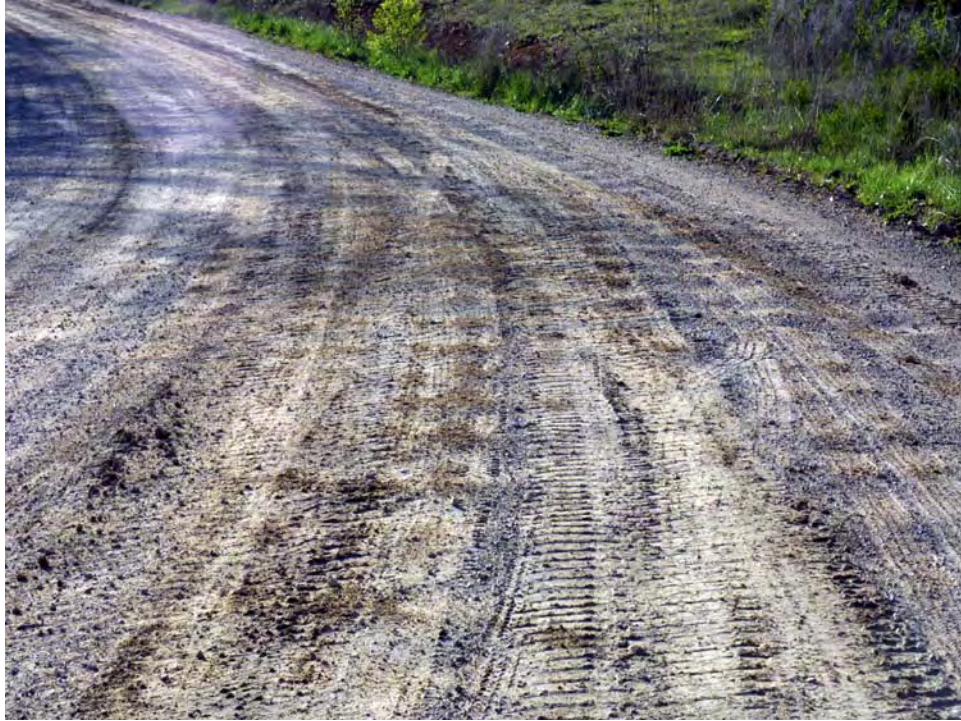
Photo 63. Corrugations along curve in untreated area of road

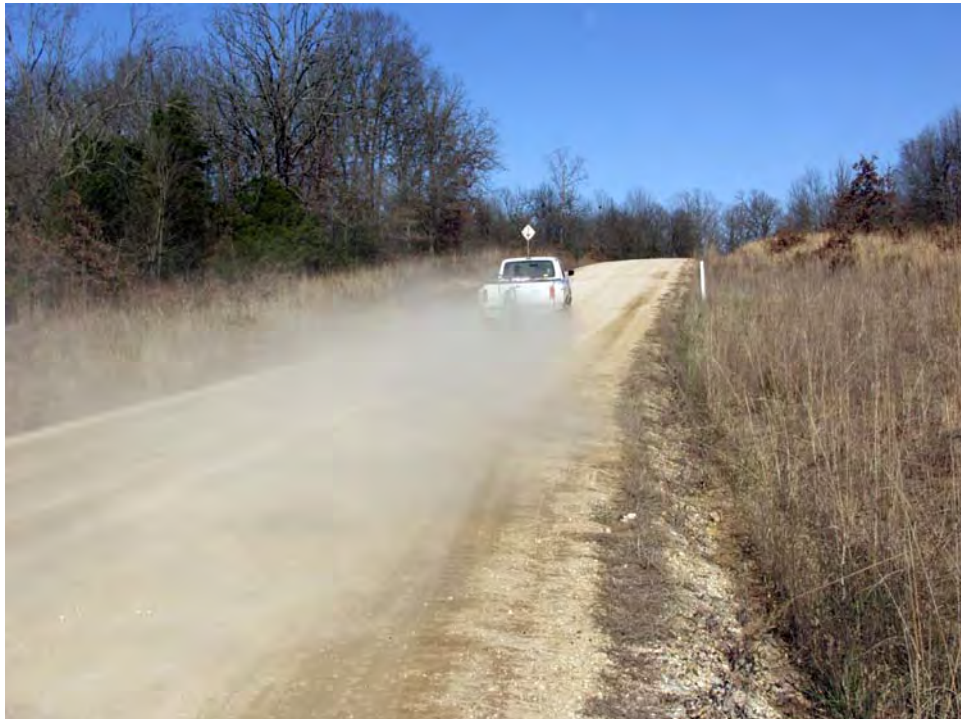
Photo 64. Section 4 (Soil~Sement® 0.8 gsy admix) – medium dust

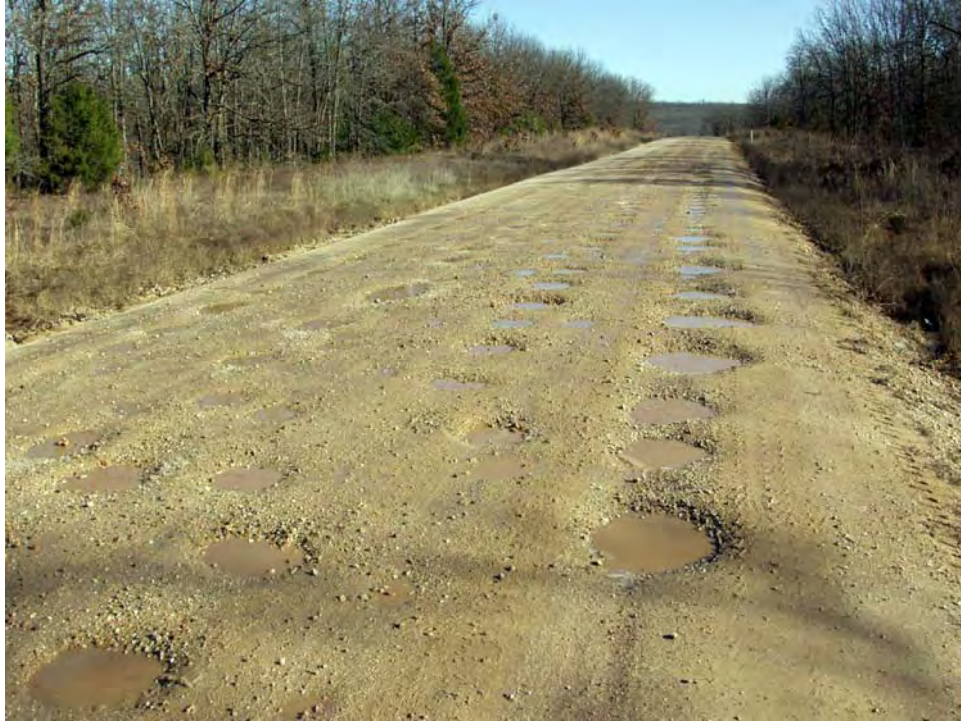
Photo 65. Section 5 (Surtac® 0.8 gsy admix) - low and medium potholes

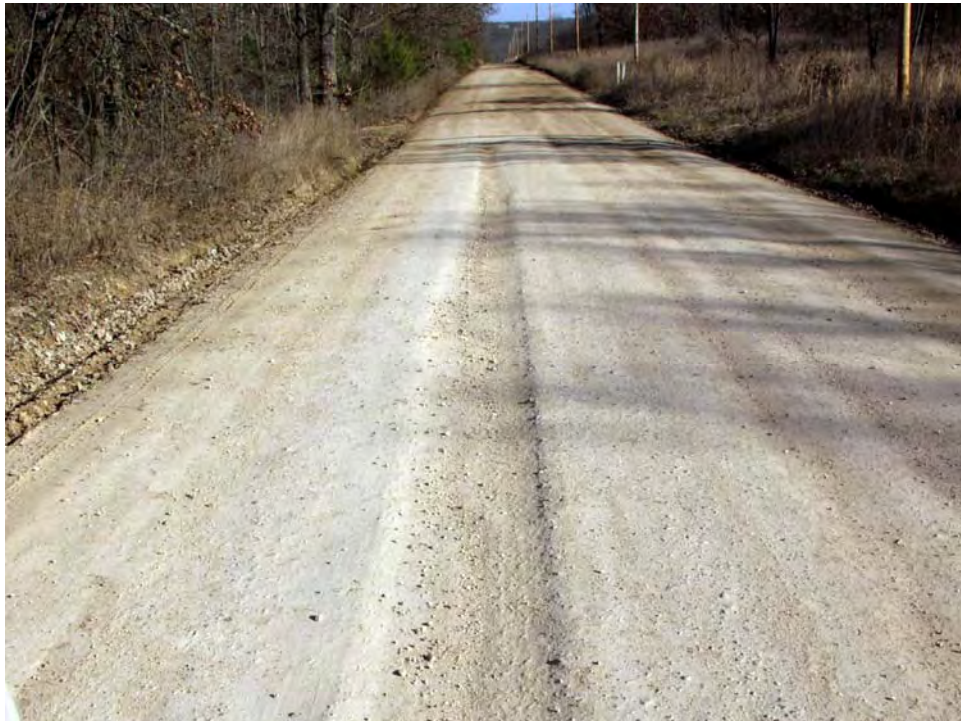
Photo 66. Section 1 (Envirotac II® 0.8 gsy admix) - low rutting
